MIAMI-DADE
COUNTY

Subject: Resolution Approving a Final Settlement Agreement with the Performing Arts Center Trust and PAC Builders for Repairs to the Rain Water Leader System at the Adrienne Arsht Center for the Performing Arts of Miami-Dade County

Agenda Item No. 8(F)(8)

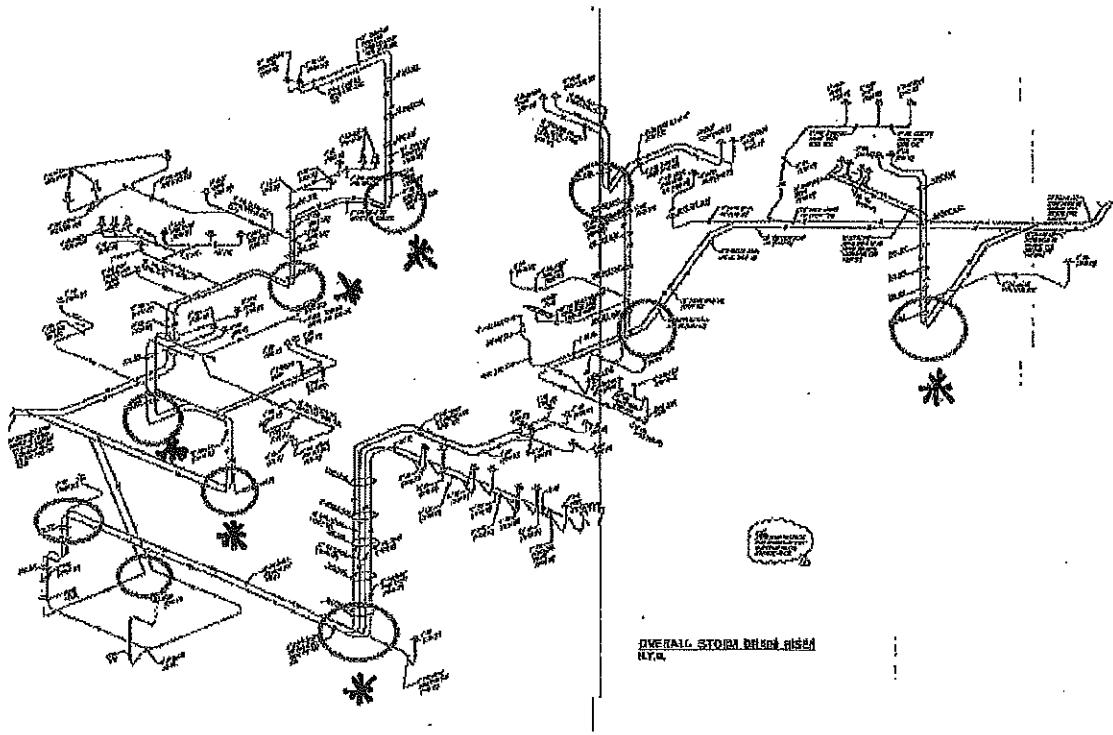
1 of 2

* INDICATE LOCATION OF PROPOSED JR'S

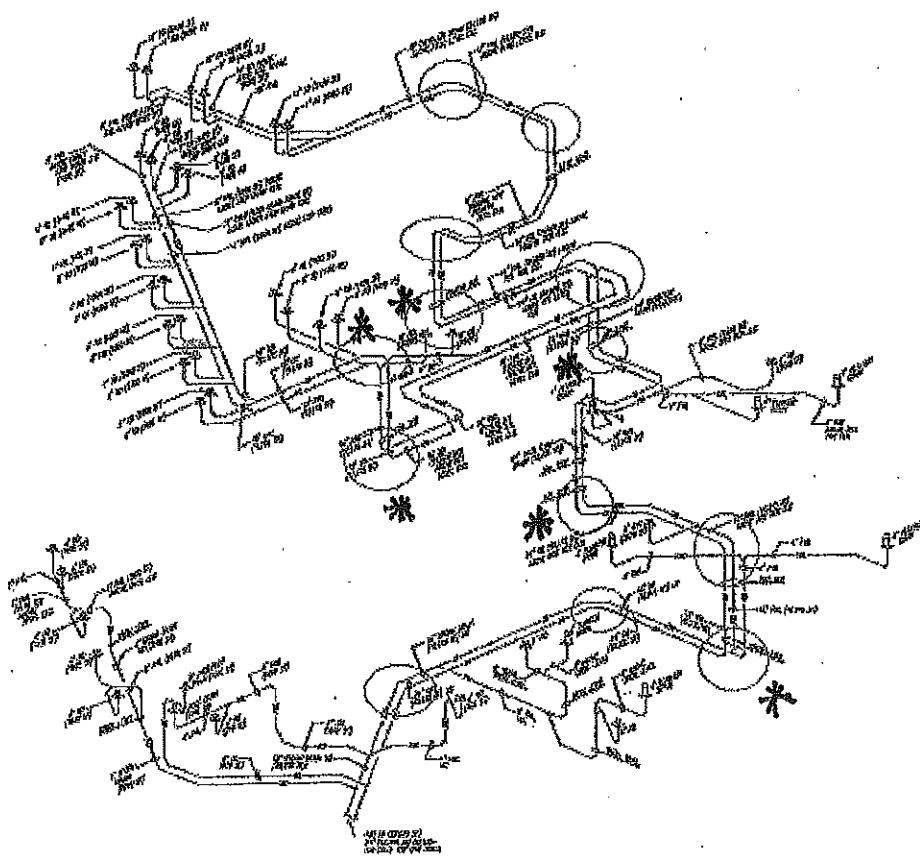
2 OF 2

* INDICATE LOCATION OF PROPOSED JPS
